ZHENGZHOU BAI-OTT NEW MATERIAL CO.,LTD

Diamond lagging sheet details

Data of Diamond Cold Bonding Pulley lagging

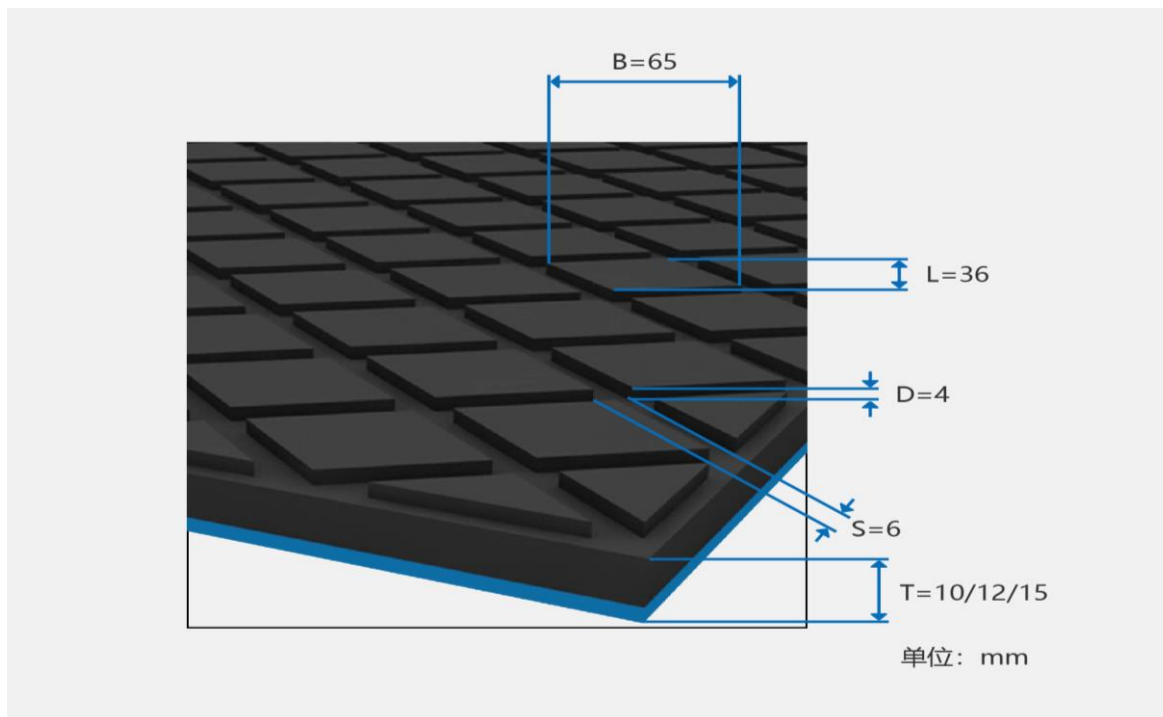
Raw Material	BR/IR/SBR
Density	1.2g/CM ³
Hardness	60±5 shore A
Wear Abrasive	63mm ³ at 10N
Tensile strength	18-20MPA
Breaking strength	20MN/M ² (MIN)
Elongation	450% MIN
Color	Black
Water Absorption	0%
Size	10/12/15/20*1500*10000mm
Uncured bonding layer	Directly stick needn't buffing it
